Property Inspection Report

June 09, 2022 (8:00 AM)

HI02012022B
123 Sample Street Sample City, NC

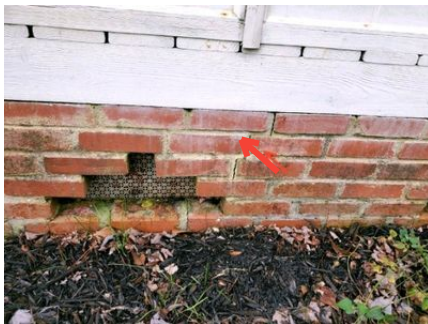
(A1-1.1) Main House

The foundation of this home is underpinned or skirted using a single brick wall. This wall does not provide structural support for the home, however, it protects the undercarriage from drainage and animals. The curtain wall for this home has openings, cracks, and needs repairs. A masonry contractor should be consulted for further evaluation and repair.

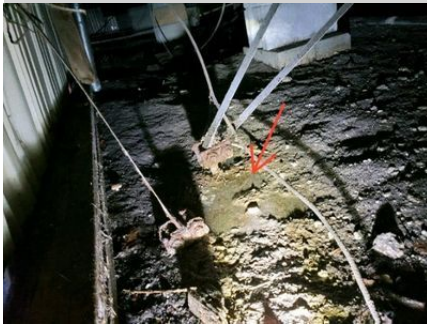
Typically manufactured homes use metal anchor or strapping system to stabilize the home for lateral or uplift forces. The anchor straps for this home were noted to be loose, damaged, rusted, and or missing. This could indicate improper installation or movement. A licensed general contractor with experience in manufactured home installation and setup should be consulted for further evaluation and repair to ensure the stability of the home.

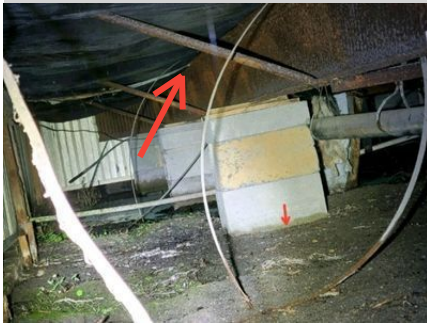
This home has a steel frame/chassis/undercarriage that provides structural support for the home. The steel frame for this home is rusted and in need of repair to prevent further deterioration. The rust on the frame indicates elevated moisture in the crawl space. A licensed general contractor should be consulted to evaluate the crawl space to correct moisture problems and repair the steel frame to correct corrosion problems.

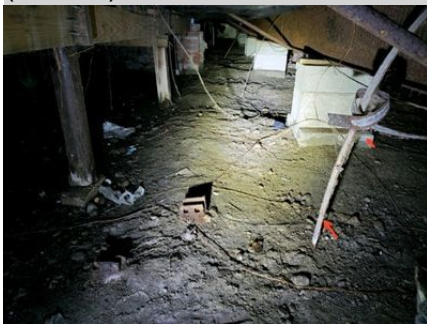
Stains and water lines indicate a history of standing water in the crawl space around the perimeter of the foundation and under the porches. Direct water penetration damages the foundation, the wood structure, and creates an undesirable environment in the crawl space areas that encourages insects and or fungal growths such as mold-mildew. Repairs are needed to prevent water penetration. Water in the crawl space indicates an absent or damaged waterproofing and foundation drain system. Repairs are needed to prevent water penetration. A licensed general contractor should be consulted for further evaluation to determine the source of the moisture and to make necessary repairs.

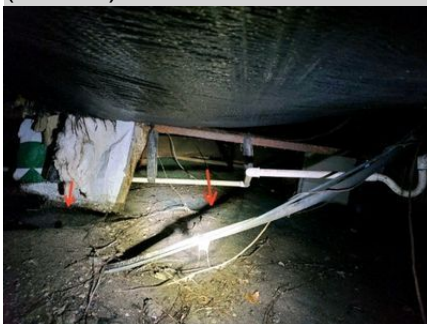
Evidence suggests that the undercarriage of the home has damage that is concealed by the belly fabric. The type or extent of damage could not be determined due to the access limitations. Damage concerns include but are not limited to plumbing systems-leaks, water damage, and structure damage. In addition buckling in the interior floors were of concern. The buyer should request disclosure related to any history of damage or repairs. An engineer should be consulted for a complete evaluation of the structure and plumbing systems and any modifications that have been made to the home.

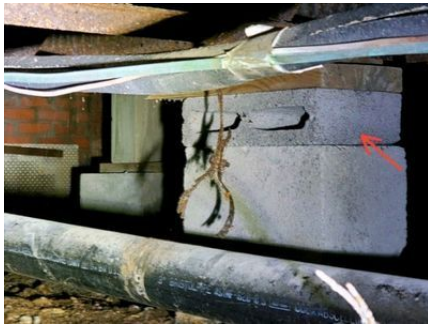
This home is a doublewide unit. The sections of the home are joined along the center to form a marriage wall. The marriage wall is directly supported by a pier row. The marriage wall of this home is not properly supported. The piers were loose and leaning. This condition could indicate improper installation or differential movement of the home. A licensed general contractor with experience in manufactured home installation and setup should be consulted for further evaluation and repair to ensure the stability of the home.

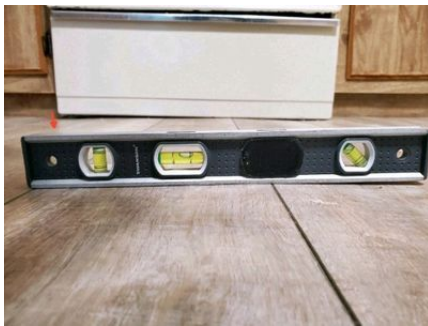
Interior floors were noted to slope more than would be typically expected. An engineer should be consulted to evaluate the structure of the home to determine the significance of this concern and if repairs are necessary. See foundation section for moisture and plumbing leak concerns.

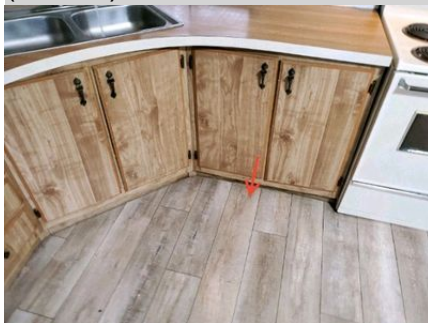
The hardwood board panels have buckled at long seams. Excessive movement of the hardwood floors can indicate improper installation and or unbalanced moisture conditions that indicate underlying problems. A flooring installation-repair company should be consulted for further evaluation to determine the significance and source of the concern.

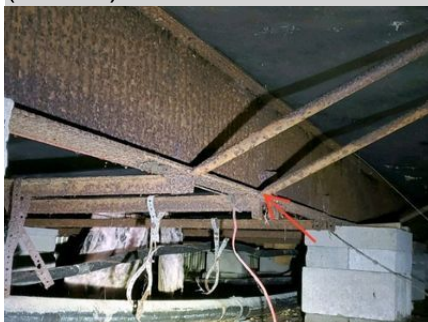
This home has a steel frame/chassis/undercarriage that provides structural support for the home. The steel frame for this home is rusted and in need of repair to prevent further deterioration. The rust on the frame indicates elevated moisture in the crawl space. A licensed general contractor should be consulted to evaluate the crawl space to correct moisture problems and repair the steel frame to correct corrosion problems.

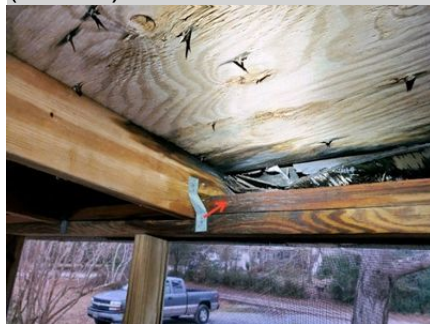
The wood framing components of the front porch in the soffit-boxing area are discolored and decayed. The level of decay indicates a history of a long term leak that could involve hidden areas of damage, the flashing, the gutters, and the roof covering systems. A licensed general contractor should be consulted for further evaluation and repair to determine the source of the leak and extent of the damage to ensure the stability of the home and prevent additional damage.

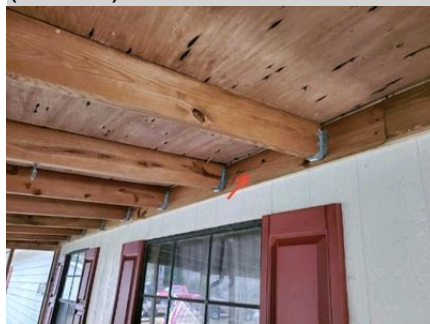
From the exterior of the home, the roof surface has visible sags located between the rafters. The low areas have displaced the roof covering materials and this condition could increase the probability of leaking. A licensed general contractor should be consulted for further evaluation and repair to ensure the weathertightness and stability of the structure.

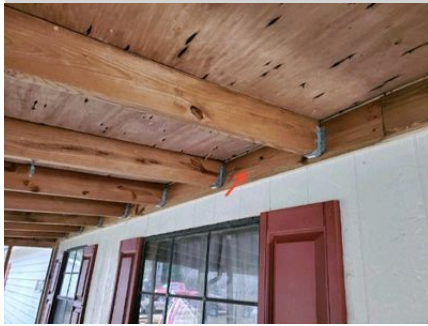
From the exterior of the home, the roof surface has visible sags located between the rafters. The low areas have displaced the roof covering materials and this condition could increase the probability of leaking. A licensed general contractor should be consulted for further evaluation and repair to ensure the weathertightness and stability of the structure.

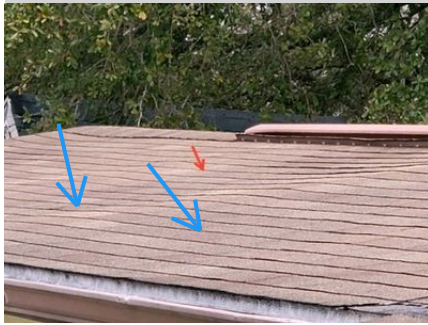
From the exterior of the home, the roof surface has visible sags where the front porch roof is attached to the mobile home. The low areas have displaced the roof covering materials and this condition could increase the probability of leaking. A licensed general contractor should be consulted for further evaluation and repair to ensure the weathertightness and stability of the structure.

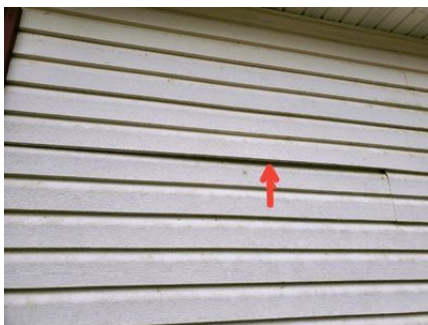
The vinyl siding pieces were noted to be loose and not snapped or zipped in place to interlock with adjacent siding pieces. This could indicate improper installation, damaged siding, and or damage to the substrate. The siding needs to be installed to create a complete cladding system covering all underlying wall components. A siding installation company or general contractor should be consulted to evaluate and repair the siding to ensure the integrity of the cladding system.

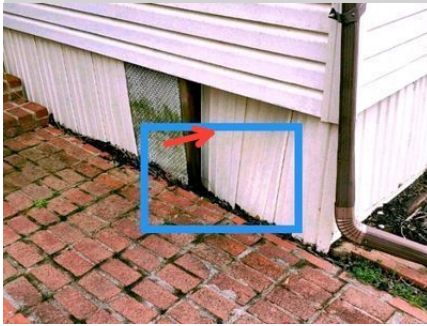
The foundation of this home is underpinned or skirted using siding panels. This wall does not provide structural support for the home, however, it protects the undercarriage from drainage and animals. The underpinning for this home needs repairs. A licensed general contractor should be consulted for further evaluation and repair.

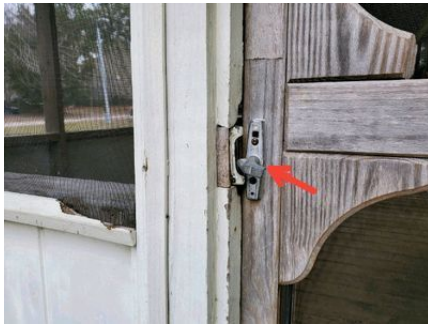
The front porch screened-storm door is in need of repair or replacement, the door would not close or latch properly. Technically a storm door is not covered by the home inspection SOP, however, when not functional, the uncontrolled movement of the door becomes a safety hazard. A repair specialist should be consulted for repair or replacement.

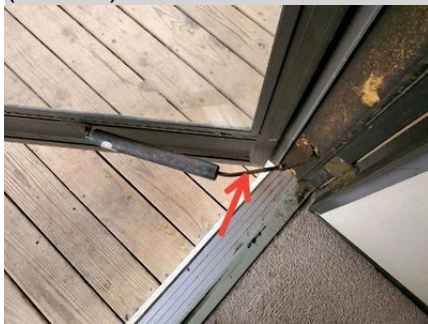
The storm door at the front entry of the home is in need of repair or replacement, the door would not latch properly and the auto closer was broken. Technically a storm door is not covered by the home inspection SOP, however, when auto closers are not functional, the uncontrolled movement of the door becomes a safety hazard. A repair specialist should be consulted for repair or replacement.

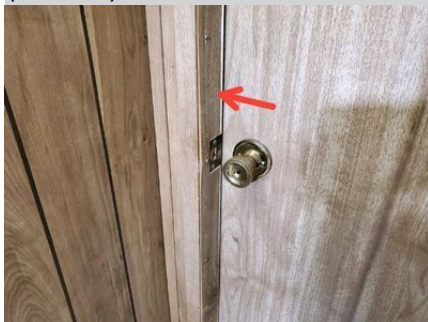
The right side main bedroom door drags, is difficult to open or close, and has no stop to prevent damage to the adjacent wall in the event the door is opened too far. This condition could indicate improper installation or framing movement. The door needs repair-replacement to ensure that the door closes securely and is weather tight. A general repair specialist or licensed general contractor should be consulted for evaluation and repair.

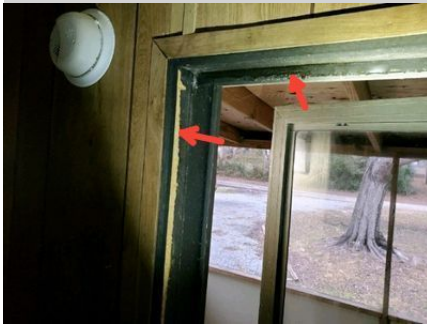
The main entrance door weather-stripping is damaged. The weather-stripping needs repair-replacement to ensure that the door closes securely and is weather tight. A general repair specialist or licensed general contractor should be consulted for evaluation and repair.

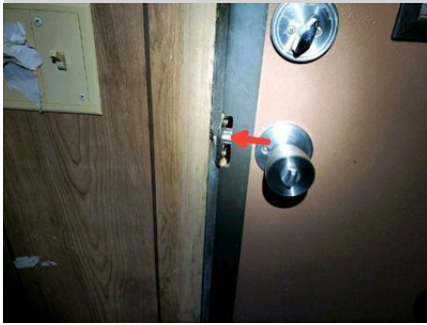
The front entrance door is misaligned, does not latch properly, and the lock assembly is damaged- not functional. The lock could not be engaged to secure the door. The lock needs repair-replacement to ensure that the door closes securely. A general repair specialist or licensed general contractor should be consulted for evaluation and repair.

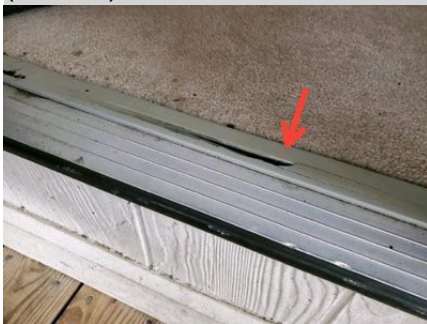
The front entry door threshold is loose, damaged, cracked, deteriorated, and improperly supported. In addition stains on the door frame-floor indicate that the door leaks at the door sill-threshold area. Water penetration can result in hidden damage and undesirable conditions. A general repair specialist or licensed general contractor should be consulted for a complete evaluation to determine the source of the leak, to locate any related damage, and repair as needed.

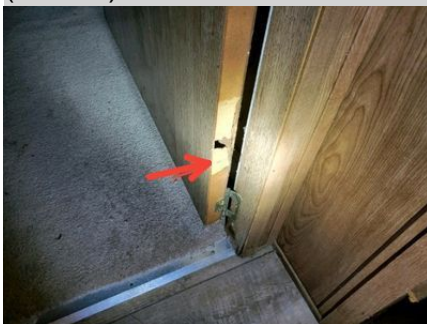
The main bedroom door is damaged split in the hinge area. The door needs repair-replacement to ensure that the door closes properly and securely. A general repair specialist or licensed general contractor should be consulted for evaluation and repair.

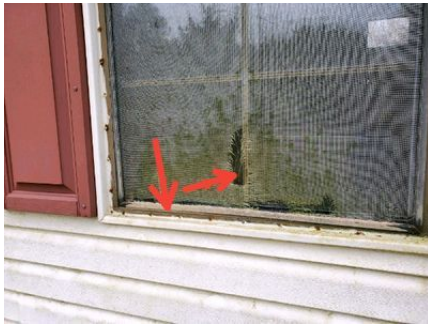
A majority of the windows in this home are in need of further evaluation and repair, the following items were noted at the time of the inspection. A complete evaluation is needed as a repair plan is developed to determine the extent of the damage.

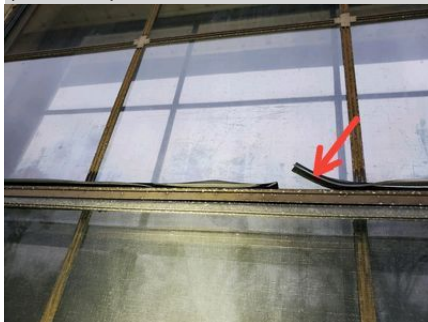
This is a photograph of the damaged or loose glazing attachment strips. The vinyl windows have a double glazed insulating sash. These units are manufactured with desiccant filled spacers between the two glass panes that are sealed by a butyl rubber or silicone gasket. The sealant gaskets for several of the windows were noted to be loose and or displaced. This could indicate that the thermal seal has been jeopardized which will allow moisture between the panes, cause a cloudy appearance, and-or reduce the energy efficiency of the window. A general contractor or window specialist should be consulted to evaluate all windows, determine the significance of this concern and make necessary repairs.

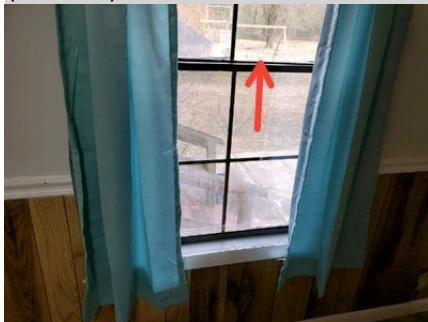
The kitchen window needs repair to ensure proper operation. The window could not be opened. A licensed general contractor should be consulted for evaluation and repair.

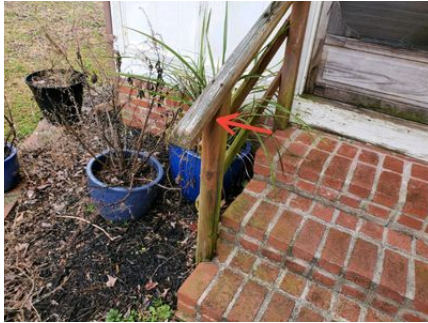
The hand railings for the porch steps are loose-damaged-decayed and in need of repair or replacement to ensure safe and functional use of the porch. A licensed general contractor should be consulted for a complete evaluation and to make necessary repairs.

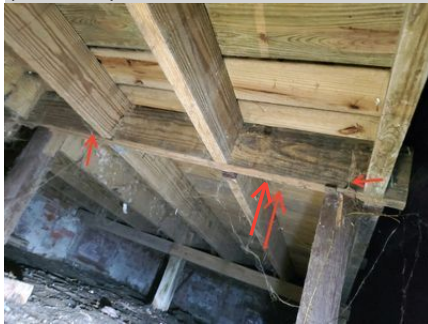
The exterior girders for the wood deck are attached to the support post by a simple nail connection only. This is an uncommon construction method. In general, girders require through bolt connections and or direct bearing at end points to prevent framing movement or failure. A licensed general contractor should be consulted for a complete evaluation and to make necessary for repairs to ensure the stability and durability of the deck.

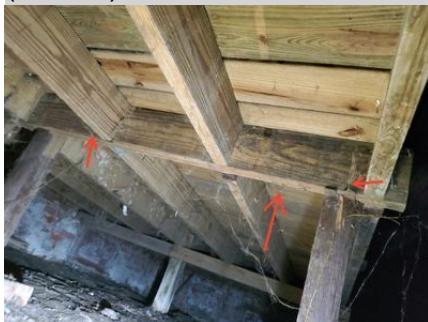
The floor joists for the deck are supported or attached by toe nail connections only. Nails can corrode and fail leaving the floor system unsupported. Improper deck construction can result in unsafe conditions and possible deck failure. A licensed general contractor should be consulted for a complete evaluation of the deck and to make necessary repairs to ensure the stability and durability of the deck.

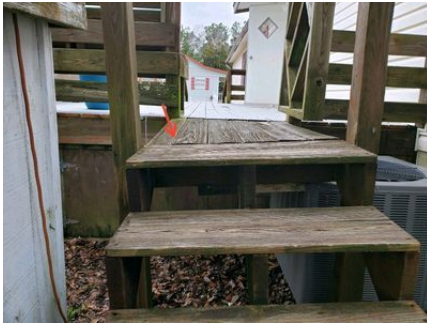
The steps for the deck were found to be in poor condition. The following concerns were noted at the time of the inspection:

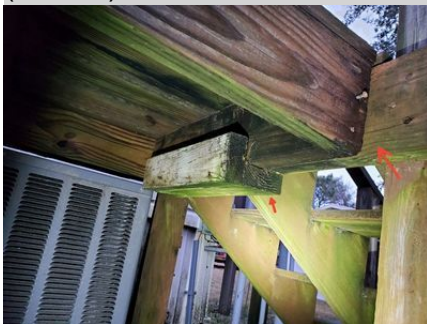
The steps for the left side of the rear deck were found to be in poor condition. The following concerns were noted at the time of the inspection:

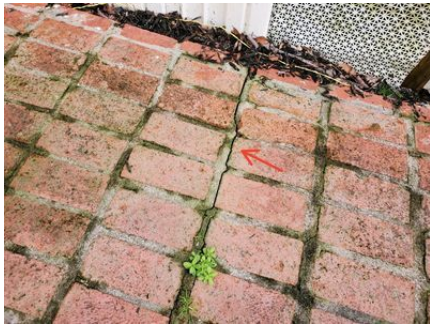
The brick pavers on the front sidewalk are cracked, loose, and covered with algae. The loose bricks have resulted in an uneven walking surface, encouraged water flow toward the home, and has created an opening where water could become trapped resulting in additional damage. A licensed general contractor should be consulted for further evaluation, to determine the extent of the concern, and to make necessary repairs.

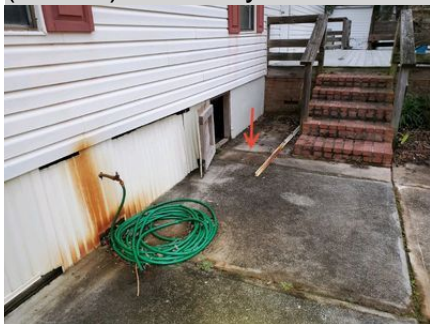
The rear sidewalk-patio area is sloped to encourage storm drainage to flow toward the home and into the crawl space. Drainage should be controlled and directed away from the foundation to reduce direct penetration and exposure. A licensed general contractor should be consulted for further evaluation and repair.

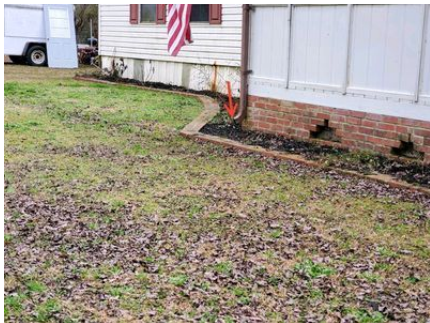
The front yard slopes toward the home and there is evidence of erosion of soil against the perimeter of the home. Corrections are needed to control drainage and prevent water penetration, a licensed general contractor should be consulted for a complete evaluation and to make necessary repairs.

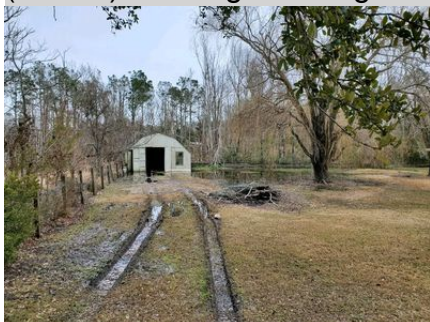
Standing water noted at rear yard and storage building at time of inspection. Improper drainage is occurring at areas. A licensed general contractor with experience in landscaping and grading should be consulted to evaluate and correct the grading as needed.

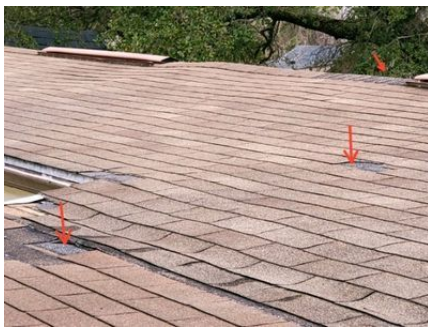
Several shingles are missing over the roof surface. The missing shingles could indicate an underlying problem with the shingle installation or the sheathing. A licensed general contractor should be consulted for a complete evaluation of the roofing systems to verify that shingles are installed correctly and to make necessary repairs to ensure the weathertightness of the roof covering system. For additional information refer to the structural section comments 2.12 and 2.13

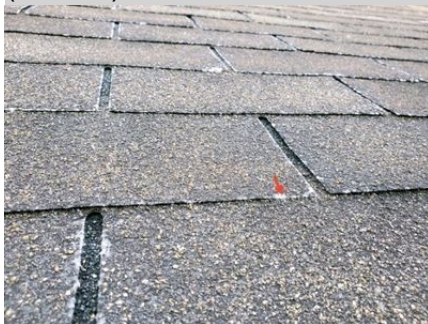
The shingles have visible signs of deterioration such as tab shrinkage, low ballast, and exposed base mat that indicate that they are approaching the end of their service life. Damaged shingles are in need of replacement. A licensed roofing contractor should be consulted for a complete evaluation of the roof covering and flashings system to make necessary repairs to ensure the weathertightness of the roof covering system. At the time of the repair, the roofer may be able to answer questions related to the life expectancy of the roof covering system.

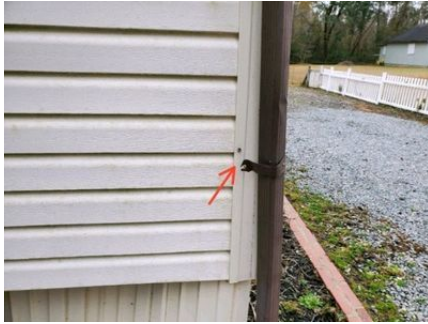
The gutter downspout at the left rear corner is damaged-clogged. Evidence on the bedding areas indicates that the gutters have been overflowing. Direct drainage to the foundation and cladding from the gutter system can result in water penetration into the foundation area and foundation deterioration. A licensed general contractor should be consulted for a complete evaluation and to make necessary repairs.

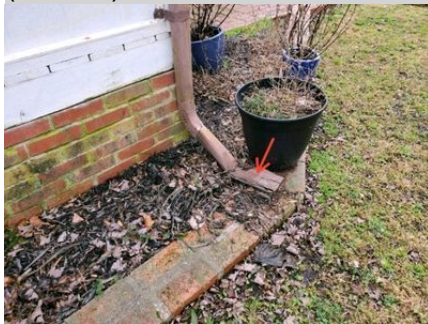
The gutter downspout at the right front porch corner is damaged-clogged. Evidence on the bedding areas indicates that the gutters have been overflowing. Direct drainage to the foundation and cladding from the gutter system can result in water penetration into the foundation area and foundation deterioration. A licensed general contractor should be consulted for a complete evaluation and to make necessary repairs.

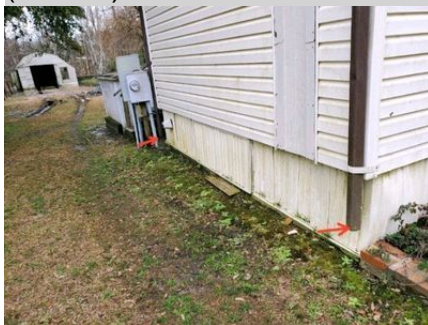
The gutter downspouts are not extended or piped to direct roof drainage away from the foundation. Direct drainage to the foundation and cladding from the gutter system can result in water penetration into the foundation area and foundation deterioration. A licensed general contractor should be consulted for a complete evaluation and to make necessary repairs.

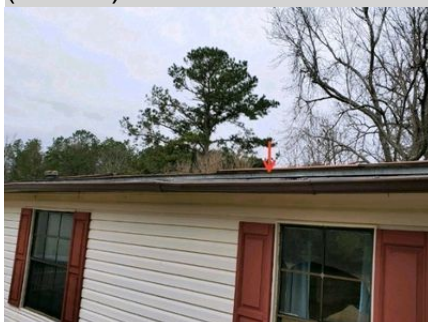
Standing water was noted in the gutter trays in several locations. This indicates that the gutters are not draining and could indicate improper tray slope, a clogged exits, or downspout extension. Direct drainage to the foundation and cladding from the gutter system can result in water penetration into the foundation area and foundation deterioration. A licensed general contractor should be consulted for a complete evaluation of the gutter system to reduce overflow and to make necessary repairs.

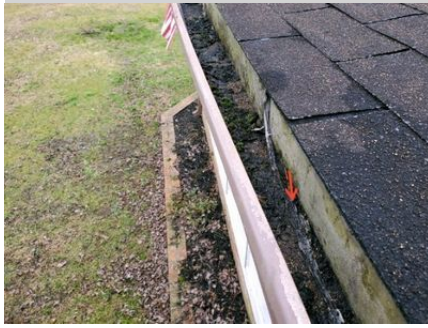
The gutters full of debris and clogged. Evidence on the bedding areas indicates that the gutters have been overflowing. Direct drainage to the foundation and cladding from the gutter system can result in water penetration into the foundation area and foundation deterioration. A licensed general contractor should be consulted for a complete evaluation and to make necessary repairs.

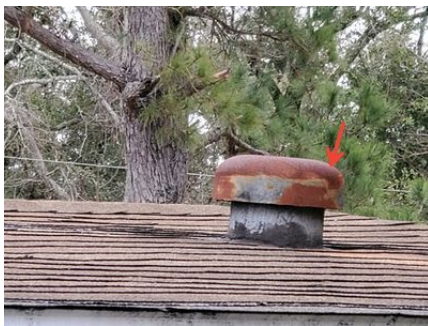
The attic fan ventilator is corroded, in poor condition, and the seam between it and the roof surface is heavily caulked and no flashing was visible. Heavy caulking is a temporary repair and an indication of a history of leaking. A licensed roofing contractor should be consulted for evaluation and repair to ensure the weathertightness of the roof covering system.

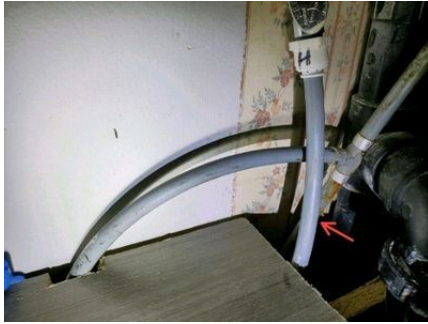
This home has a plumbing supply system that uses polybutylene plastic distribution lines and compression band fittings. Even though this plumbing system was installed in many homes from 1978 until mid-1990 s, it is no longer manufactured in the original formulation as an approved plumbing system due to a history of material failures. The failures were related to improper installation, improper handling, improper storage, and plastic deterioration due to chemical reactions with the water supply. Due to the nature of this latent defect, it was not possible to adequately assess the condition of the plumbing system during the home inspection. A licensed plumbing contractor should be consulted for a complete evaluation of the plumbing system to determine the significance of this concern.

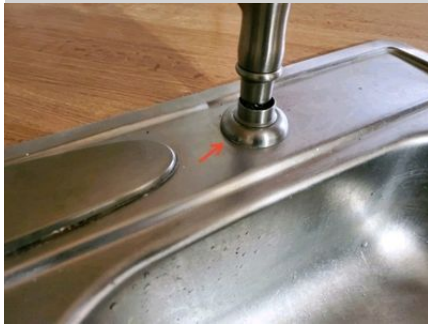
The faucet was noted to be loose and in poor condition. Repair is needed to ensure proper service. A licensed plumbing contractor should be consulted for evaluation repair/replacement.

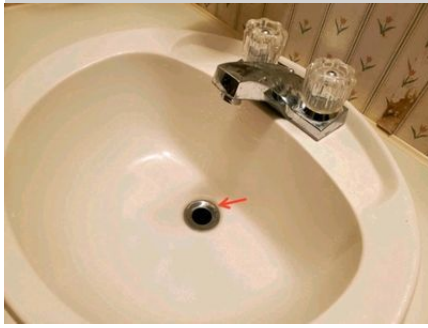
The sink and bathtub drain stoppers were missing and damaged in the hall bathroom. The stopper blocks the flow of water into the drain so the sink or tub can be filled. A licensed plumbing contractor may be needed to replace the drain assembly if this is of concern and repair parts are not available.

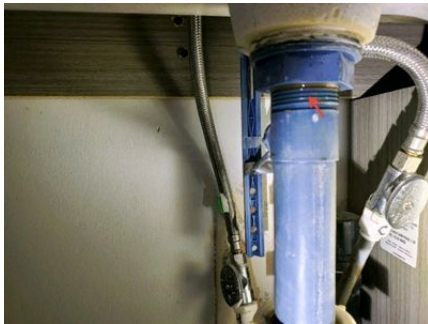
The waste line tail piece located under the sink in the hall bathroom is cracked and leaking. The cracked drain components need to be replaced to ensure sanitary conditions. A licensed plumbing contractor should be consulted for evaluation and repair.

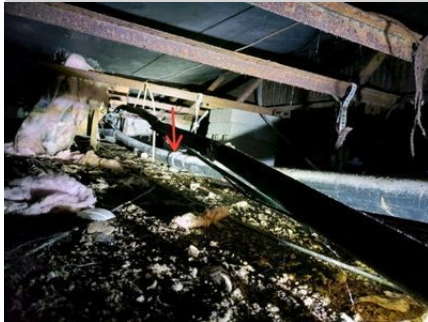
The main waste line was noted to be holding water and the pipe supports are damaged and corroded. This condition could indicate that the waste line is clogged or not sloped to drain. A licensed plumbing contractor should be consulted for complete evaluation of the waste line systems to determine the general condition of the system and to make necessary repairs.

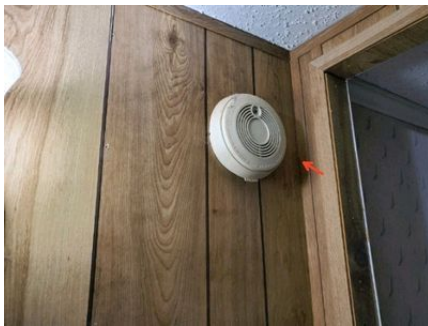
The smoke detector in the hallway did not function when operated with the test button and or standard test methods. The unit should be repaired or replaced to ensure a safe environment.
