Property Inspection Report

Report Number: HI1234 For The Property Located On:

123 Sample House Sample City, North Carolina 27215

Date of Inspection: Thursday, June 23, 2022

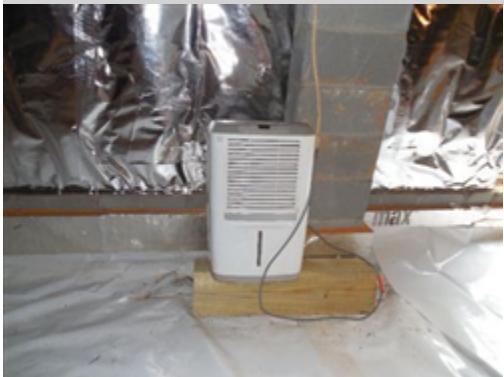
(A1 - 1.1) Main House

This home has a mechanically ventilated closed crawl space that uses dehumidification equipment for moisture control. Dehumidifiers that are used in closed crawl spaces should be a continuous duty type unit that is permanently installed and provided with a GFCI protected electrical outlet. The light duty unit installed in this home is portable and powered by the use of an extension cord. The general contractor should be consulted to review the installation and make necessary corrections to ensure that the closed crawl space system functions properly. Please note that closed crawl space systems require seasonal inspection and annual maintenance, the buyer should consult the contractor for more information concerning the recommended maintenance schedule and associated warranties.

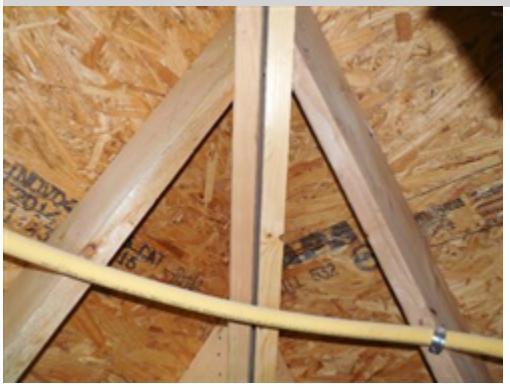
(A6 - 1.1) Main House

From that attic area over the master bedroom area, the members of the hip beam were to be separated. Typically the members should be secure to each other to ensure that they act as a beam. A licensed general contractor should be consulted for a complete evaluation, to determine the significance of this concern, and outline repairs if needed.

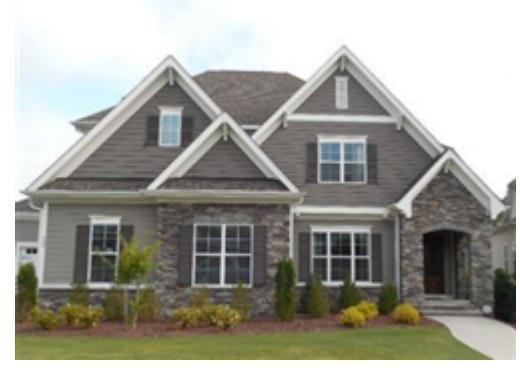
(B1 - 1.1) Main House Front Accent Areas

Adhered masonry stone-manufactured stone veneer cladding has been installed on this home. An inspection of the visible components suggests that the cladding system may not have been installed in such a way as to ensure that the cladding is a weather-resistant system that protects the wall assembly from excessive water penetration, condensation, and or water accumulation. At the time of inspection, the following concerns were noted and in need of further evaluation:

- A weep system was not observed either at the base of the framed walls or at the termination of the veneer.

- A weep system was not observed at transitional intersections with adjacent cladding materials and trim.

- Transitional flashing, drip screed, and sealant details were not observed for window and door openings.

- Standard clearances, transitional flashing, weep screed, and sealant details were not observed for at intersections with roof covering materials

- Standard clearance, flashing and sealant details were not observed at boxing areas, eaves and rakes.

- Standard flashing and sealant details were not observed at wall penetrations for light fixtures, receptacle boxes, or dryer duct exit. Additional concerns related to the installation are listed below:

- Clearances were not maintained between stone cladding and the ground and-or paved surfaces to prevent wicking and frost heave problems.

- Clearances were not maintained between stone cladding and roofing materials to allow for proper drainage and future roof repairs and-or replacement.

The installation of the stone cladding should be evaluated by a licensed general contractor and repaired as needed to correct any possible water penetration issues and verify that the stone cladding is installed to the specific installation requirements of the North Carolina State Building Code: Residential Code and -or the Masonry Veneer Manufacturer-s Association (MVMA). Please note that because the water resistive barrier, metal lath, and base coat(s) of cement stucco are completely concealed behind the adhered masonry stone veneer cladding, they cannot be evaluated by a visual inspection.

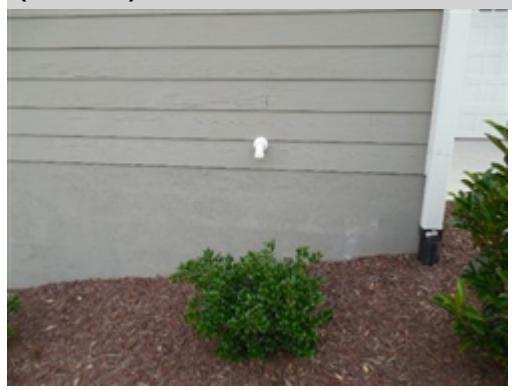
(B1 - 2.1) Main House

The exterior of the home was noted to have several loose siding boards. The loose siding boards can indicate improper installation, failure of the fasteners, and or problems with the sheathing. A licensed general contractor should be consulted for a complete evaluation of the exterior of the home to evaluate the siding installation, the condition of the underlayment, and to correct the loose boards to ensure the weathertightness of the system.

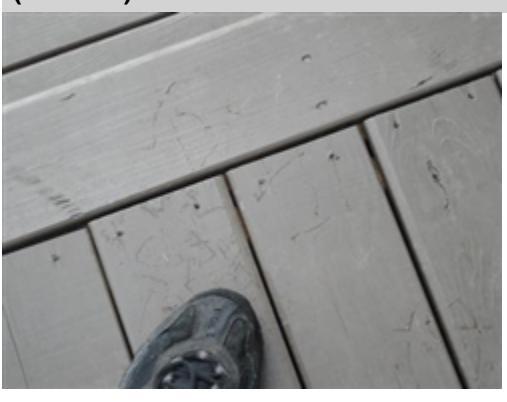
(B3 - 1.1) Deck

The deck surface boards are loose in a few areas. A licensed general contractor should be consulted for a complete evaluation and to make necessary repairs to ensure the boards are secure to prevent cupping and possible trip hazards.

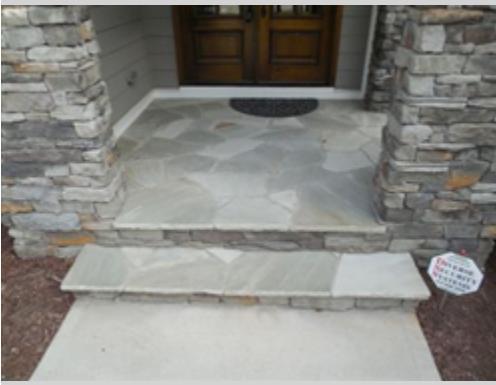
(B3 - 2.1) Porch

The steps at the entrance of the home have a noticeable variance in the height of the first step and nosing projection. This configuration could result in the trip or fall hazard as someone enters or leaves the home. A licensed general contractor should be consulted to review the steps and repair as needed to ensure safe access and egress.

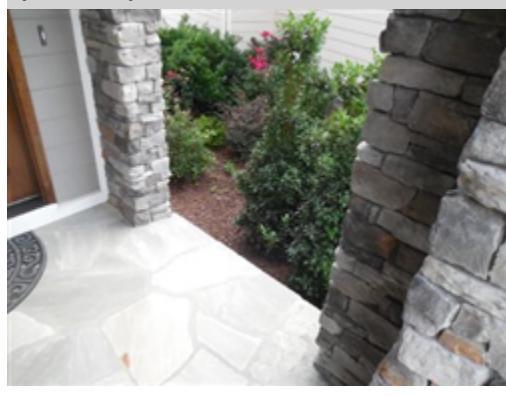
(B3 - 2.2) Porch

The stones tiles on the porch pad are loose. The loose tiles have resulted in an uneven walking surface and created openings where water could enter the foundation area. A licensed general contractor should be consulted for further evaluation, to determine the extent of the concern, and to make necessary repairs.

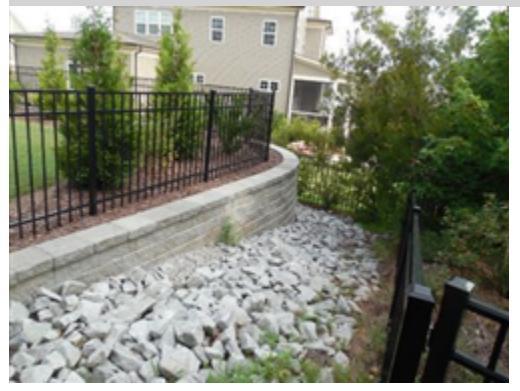
(B5 - 1.1) Retaining Wall

On the backside of the home the area behind the retaining wall adjoins the neighbors fence. The slope between the two lots adjacent to the retaining walls system is covered with large rocks, however, evidence of drainage and erosion were noted. A licensed general contractor with experience with lot grading should be consulted for a complete evaluation to determine the significance of this concern and repair as needed.

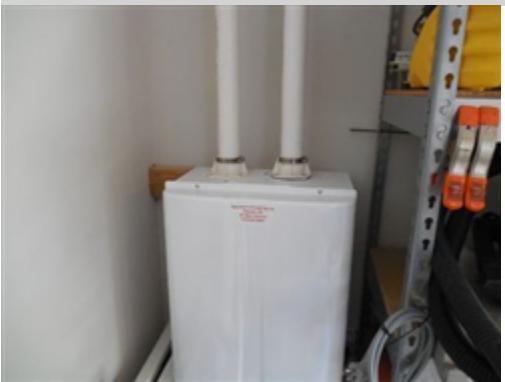
(D3 - 1.1) Unit 1

Manufacturer: State Serial Number: VA6709737DV Model Number: DV3F87Jk Date: 02-2019

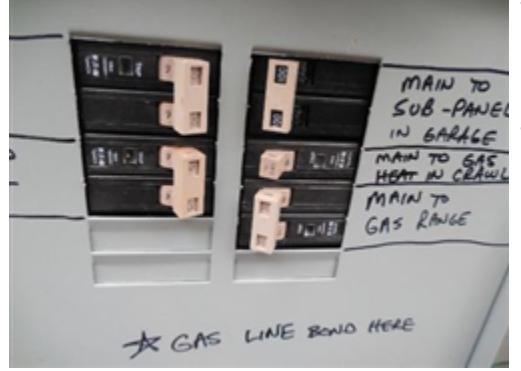
(E2 - 1.1) Main Panel 1

The service breaker and conductor identified for the subpanel are compatible but undersized for the subpanel. This configuration derates the 200 amp subpanel rating to 100 amps. A licensed electrical contractor should be consulted for repair and a complete evaluation of the electrical system to ensure that it is capable of handling the imposed loads.

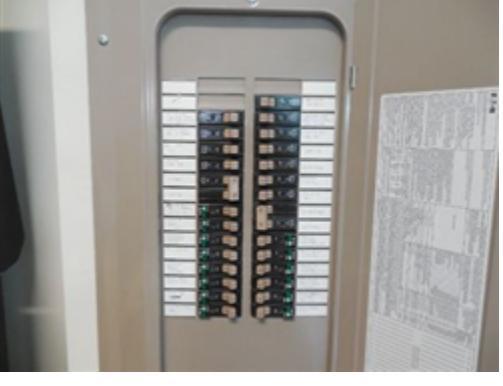
(E3 - 1.1) Distribution Panel 1

Photo of Sub Panel located in garage

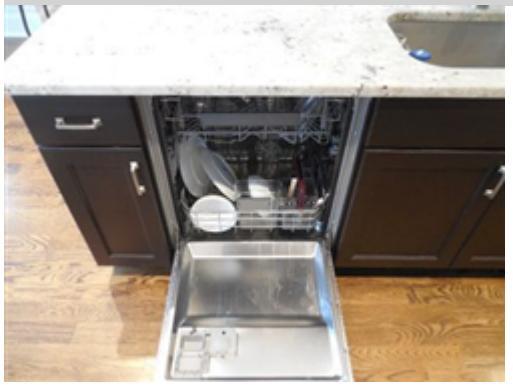
(J1 - 1.1) Dishwasher

The door for the dishwasher is difficult to latch. If the door latch is not completely engaged the dishwasher will not function properly. An appliance repair specialist should be consult for a complete evaluation and repair/replacement of the dishwasher.
