Property Inspection Report

June 09, 2022 (8:00 AM)

HI02012022B
123 Sample Street Sample City, NC

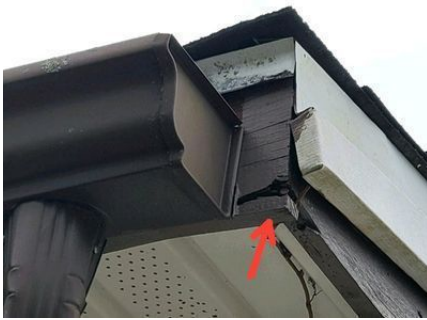
(B1-1.3) Main House

Fascia cladding is cracked or damaged at front right exterior area of residence. The exterior of the home has been upgraded with vinyl siding. Wood trim including the fascia at the right front corner, windows, and exposed hardboard type sidings were noted to be deteriorated. It is suspected that other areas of damage were covered with the new vinyl and aluminum trim. Deterioration of exterior components can result in water penetration into the living areas and foundation which can result in structural damage and undesirable environmental conditions contributing to fungus-mold-mildew growth. A licensed general contractor should be consulted to repair all visible damage and check the home for possible areas of hidden damage.

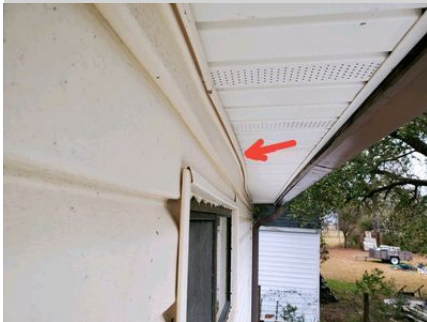
(B1-1.4) Main House

The siding was noted to be wavy. This may be caused by concealed damage see comment 1.1.3 above or that the siding was observed to be installed tightly without leaving room for expansion during summer months. Without proper expansion and contraction clearances the siding may buckle or become loose. A siding installation company or general contractor should be consulted to evaluate and repair the siding to ensure the integrity of the cladding system.

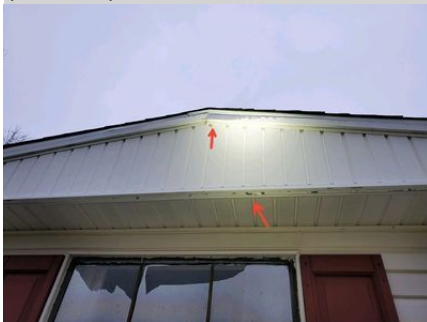
(B1-1.5) Main House

The siding for this home has a decorative trim between the levels. During the inspection it was noted that the trim piece was abutted to the siding J channel and was installed without a Z or other flashing to prevent water from the upper siding level from draining behind the trim piece and the lower siding panels. A licensed general contracting company and a certified vinyl siding installer should be consulted to inspect the condition of the wood framing and sheathing and verify the siding -flashing installation.

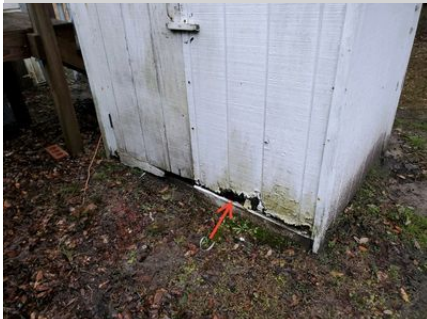
(B1-1.6) Main House

Moisture damage is noted at wood wall components at rear exterior well pump house at residence. Further deterioration and improper operation may occur. A qualified contractor is recommended to evaluate and make any needed repairs or improvements.

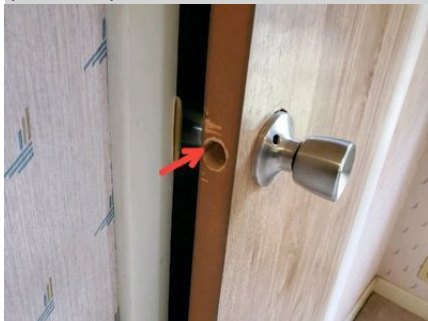
(B2-1.3) Doors

The door lock assembly to the main bedroom closet is damaged, missing components, and is not functional. The lock could not be engaged to secure the door. The lock needs repair-replacement to ensure that the door closes securely. A general repair specialist or licensed general contractor should be consulted for evaluation and repair.

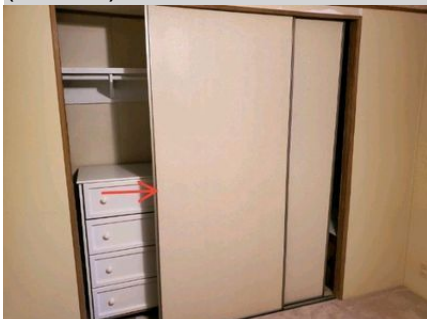
(B2-1.9) Doors

The main bedroom right side sliding closet doors do not function properly and are difficult to operate, the track was damaged or misaligned. A licensed general contractor should be consulted for further evaluation and repair to ensure proper operation and safe egress.

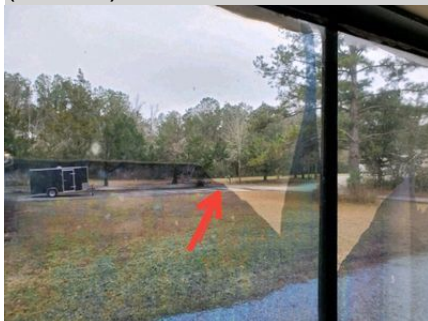
(B2-2.4) Windows

This is a photograph of the tint film applied to the inside surface of the windows that is damaged at various locations throughout the home. This is mentioned for your consideration.

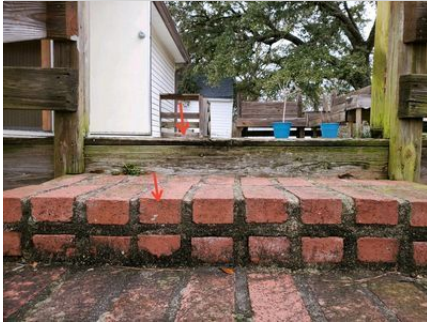
(B3-2.2) Porch: Patio: Deck

The steps at the entrance of the home have a noticeable variance in the height of the last step. This configuration could result in the trip or fall hazard as someone enters or leaves the home. A licensed general contractor should be consulted to review the steps and repair as needed to ensure safe access and egress.

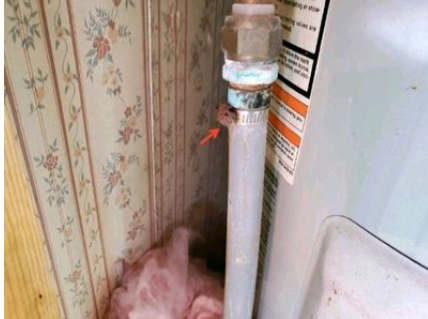
(D2-1.3) All Accessible Areas

Nonstandard plumbing repairs and moisture stains noted at plumbing supply line at water heater area of residence (applied pipe worm clamp with corrosion present at plumbing coupling). No leaks noted at the time of inspection. This suggests an old or intermittent leak. Recommend subsequent observation and or further evaluation of repairs for adequacy by a qualified plumbing contractor.

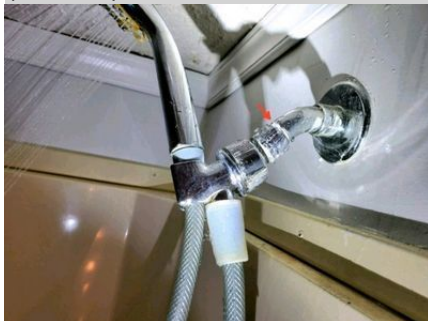
(D2-1.4) All Accessible Areas

The shower head piping is dripping in both the hall and main bathrooms. A licensed plumbing contractor should be consulted for evaluation and repair to ensure proper service.

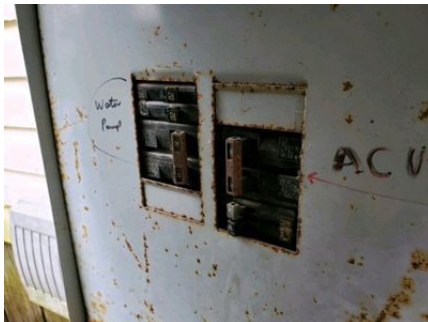
(E3-2.1) HVAC Sub Panel

The service breakers in the panel are not properly identified or labeled. Proper labeling ensures adequate service for appliances and sub-panels and the overall safety of system when emergencies occur or repairs are needed. Without proper labels the inspector's ability to evaluate and inspect system is greatly reduced. A licensed electrical contractor should be consulted for a complete evaluation to label all electrical panels, subpanels, and service breakers and verify the compatibility of the configuration.

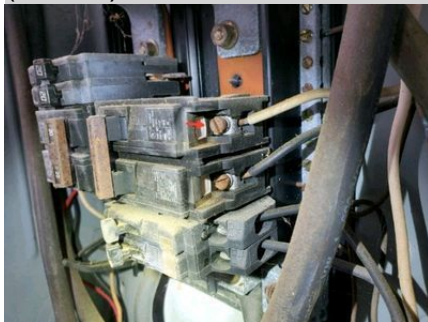
(E3-2.2) HVAC Sub Panel

Several breakers located in the panel were noted to have visible water marks and corrosion. Evidence suggests a history of water penetration or moisture into the panel which could result in personal injury or property damage. A licensed electrical contractor should be consulted for repair and a complete evaluation of the electrical system.

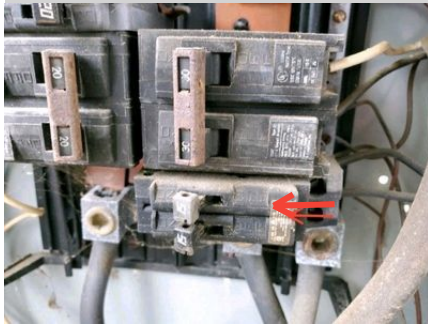
(E3-2.3) HVAC Sub Panel

Several breakers in the electrical panel have been added or replaced. The new breakers are of a different brand from the panel enclosure and are not listed on the label of the panel. Breakers must be UL listed and certified for each panel to ensure proper operation. The compatibility of the breakers to the panel needs further evaluation by a licensed electrical contractor to ensure safe and proper operation of the overcurrent protection systems.

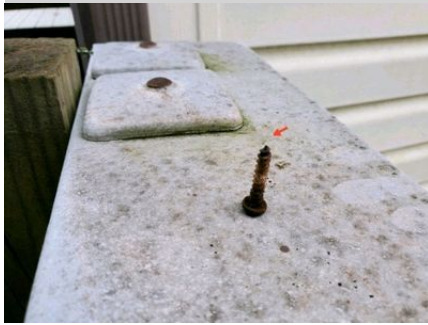
(E3-2.4) HVAC Sub Panel

The HVAC electrical service panel cover is installed with the wrong type of fasteners. The door-cover prevents direct contact with hot electrical circuits and contains the electrical energy of the electrical system in the event of a short or electrical explosion; therefore the cover must be secured with the correct type, size and number of fasteners. This condition presents a safety hazard that could result in serious personal injury or death. A licensed electrical contractor should be consulted for a complete inspection of the electrical system and for repair-replacement of the panel to ensure that it is safe and functioning properly.

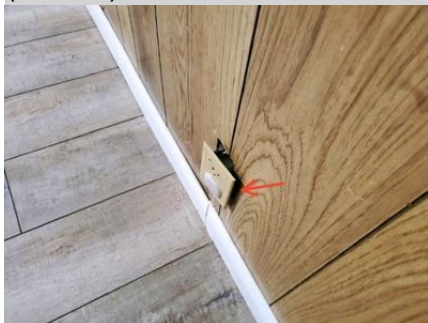
(E5-1.2) Residence

The receptacles in the hallway and main bedroom are loose. Loose receptacles could result in electrical shock hazard or property damage. A licensed electrical contractor should be consulted for a complete evaluation to determine the significance of this concern and make necessary repairs to correct defects and prevent safety hazards.

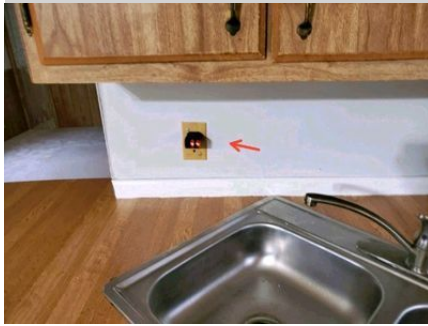
(E5-1.3) Residence

The receptacles in the kitchen, hall bathroom, and exterior of the home are not GFCI protected. Receptacles located in hazardous or wet locations should be GFCI protected to reduce shock in hazardous locations. A licensed electrical contractor should be consulted for further evaluation and repair.

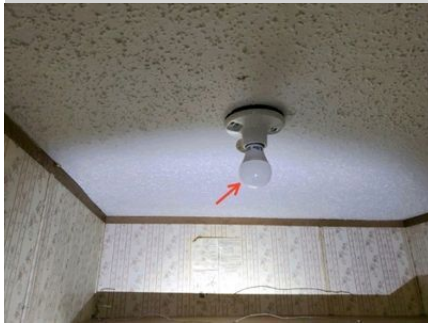
(E5-1.4) Residence

The light fixture located in the main bedroom closet is an incandescent type that poses a fire hazard-risk if it comes in contact with storage items. A licensed electrical contractor should be consulted for replacement of this fixture with one that is designed for a clothes-storage closet.

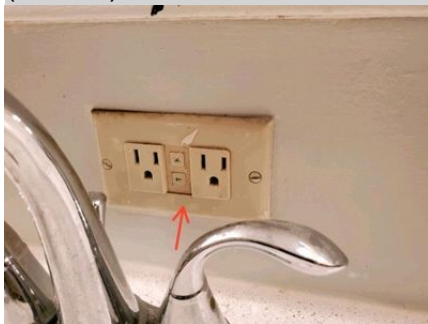
(E5-1.5) Residence

The GFCI receptacle for the main bathroom did not operate properly when tested. The GFCI is an important safety feature that should be kept functional to reduce shock hazards. A licensed electrical contractor should be consulted for repair.

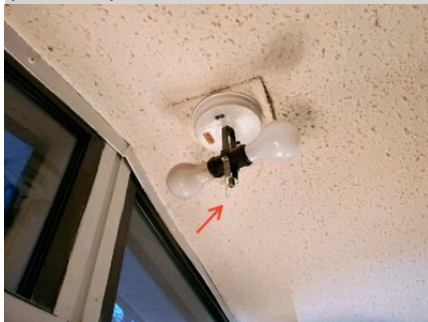
(E5-1.6) Residence

The light fixture is damaged. Damaged fixtures could result in improper operation and electrical hazards. A licensed electrical contractor should be consulted for further evaluation and repair.

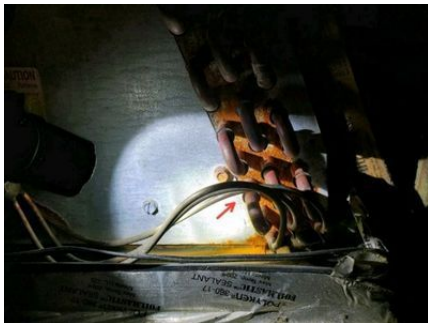
(F1-1.1) Heating Unit(s)

The heat pump was not operating properly at the time of the inspection. The inside coil-air handler was found to be in poor condition, damaged fins, corrosion, damaged casing. A HVAC contractor should be consulted for a complete evaluation and to make necessary repairs to ensure safe, reliable, and proper operation of the HVAC system.

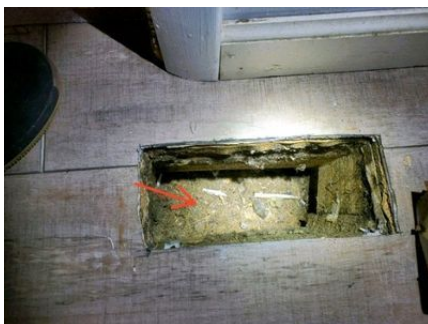
(F2-1.1) Heating Unit(s)

Several branch ducts are heavy and filled with debris. The debris reduces the air flow and contaminates the air supply. A HVAC contractor should be consulted for a complete evaluation and replacement of all damaged duct components to ensure reliable and proper operation of the HVAC system.

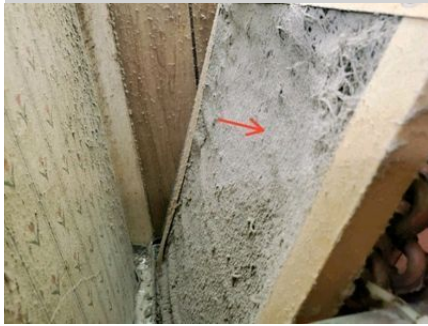
(F2-1.2) Heating Unit(s)

The return air filter in the home was found to be clogged. A clogged filter reduces add load to the system that can result in premature failures. A HVAC contractor should be consulted for a complete evaluation and service of the system to ensure reliable and proper operation.

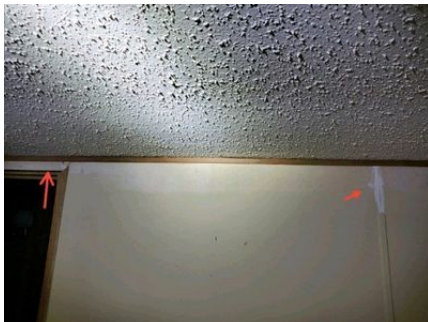
(H1-1.1) All Rooms

The textured ceiling covering was noted to be loose in several areas on the ceiling. The loose texture indicates improper texture installation or elevated moisture levels. A general repair specialist should be consulted to determine why the texture is loose and repair as needed to prevent further damage.

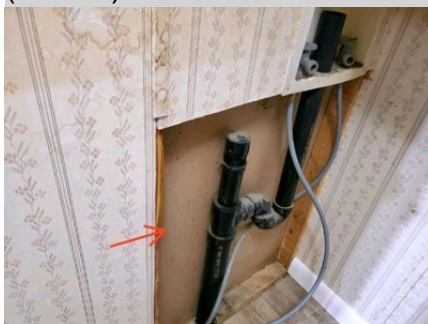
(H1-1.2) All Rooms

The wall area at the laundry supply was noted to be the damaged. The damage could be related to a leak of the washing machine drain or supply lines which could have resulted in hidden damage. A licensed general contractor should be consulted for a complete evaluation to determine the significance of this concern and make necessary repairs. A licensed plumbing contractor should be consulted for a complete evaluation to determine the significance of this concern and make necessary repairs to prevent leaks and ensure sanitary conditions.

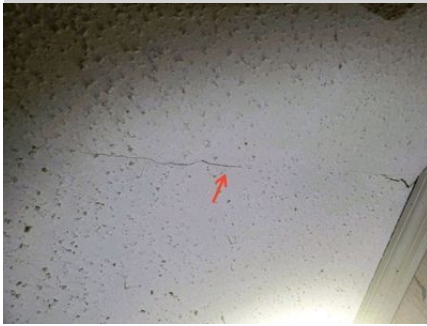
(H1-1.3) All Rooms

The ceiling is cracked. No related concerns were noted throughout the adjacent inspection areas. The buyer should review the area of concern. If additional concerns or questions are present, invasive inspection and repair will be needed. A general repair specialist should be consulted for evaluation and repair to ensure that the ceiling is secure.

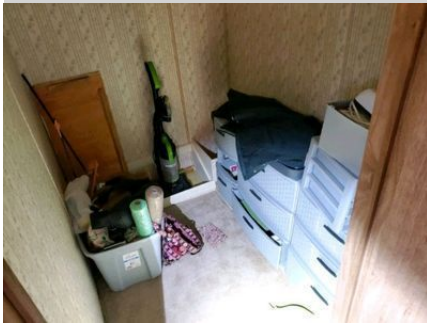
(H1-1.4) All Rooms

The closet was not accessible for inspection due to storage. The inspection of closet walls and ceilings is an important part of a home inspection. The buyer should observe the closet areas after storage has been removed prior to closing, any concerns should be brought to the attention of the inspector for further investigation.

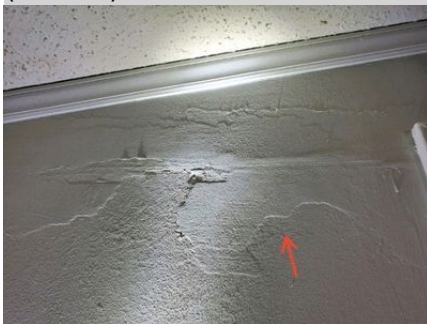
(H1-1.5) All Rooms

Evidence suggests that the ceiling has been repaired/painted. The owner should be asked for disclosure related to the extent of any related repairs, leaks or problems and the reason the ceiling was painted. New paint can limit the inspection as all history of defects or concerns are not visible.

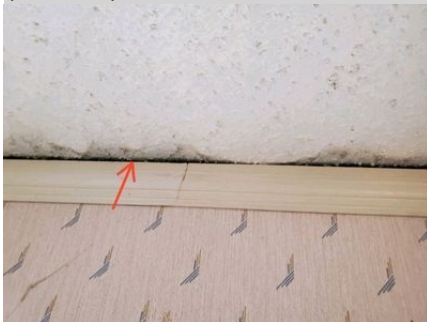
(H1-1.6) All Rooms

Water stains on the walls coming down from the ceiling indicated a history of a leak. At the time of the inspection, the source of the leak present or past could not be determined. The attic access was limited and the area above this concern could not be investigated. The homeowner should be asked for disclosure related to the history of the leak and past repairs. A licensed general contractor should be consulted for further evaluation and to make necessary repairs.

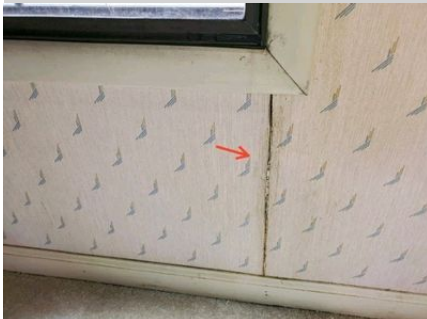
(H1-1.7) All Rooms

Stains below the window indicate a history of leaks. Leaking at window locations can allow water into the walls areas and result in hidden damage and undesirable environmental conditions. A leak at a window area can be related to the window unit, the window installation or the adjacent flashings. A licensed general contractor should be consulted for a complete evaluation to determine the source of the leak and make necessary repairs.

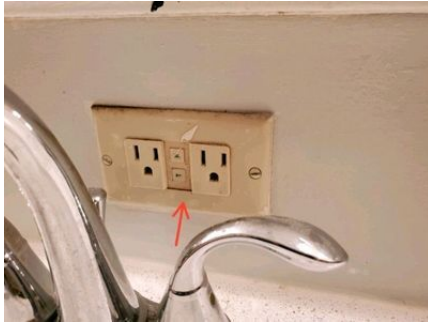
(H2-1.1) Kitchen

The GFCI receptacle for the kitchen did not operate properly when tested. The GFCI is an important safety feature that should be kept functional to reduce shock hazards. A licensed electrical contractor should be consulted for repair.

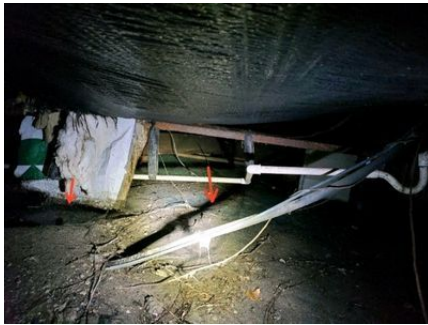
(I1-2.1) Crawl Space

The insulation was concealed under a vapor barrier or bell fabric and is not accessible and there are no apparent intake or exhaust sources for ventilation. See foundation section for concerns including improper ventilation that could result in condensation, over heating of the building components, and inadequate conditioning of the living areas. A licensed general contractor should be consulted for a complete evaluation to determine the significance of the concern and make necessary repairs.

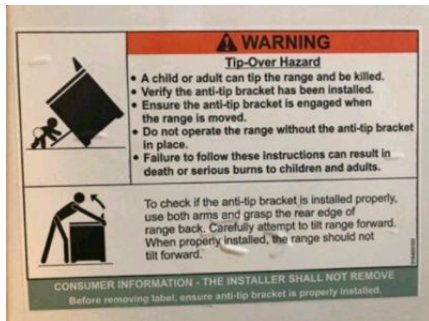
(J1-1.1) Range

The oven/range moves forward when the door is opened. The oven needs to be secured or anchored with an anti-tip bracket to prevent the unit from turning over when weight is applied to the door. An appliance repair specialist or general contractor should be consulted for further evaluation and repair.

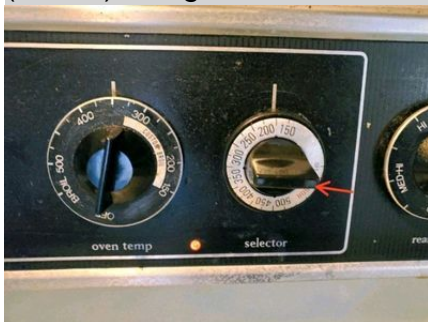
(J1-1.2) Range

The wrong selector knob installed at bake or broil selector at kitchen range control panel did not function properly. An appliance repair specialist should be consulted for further evaluation and repair to ensure proper operation of the appliance.

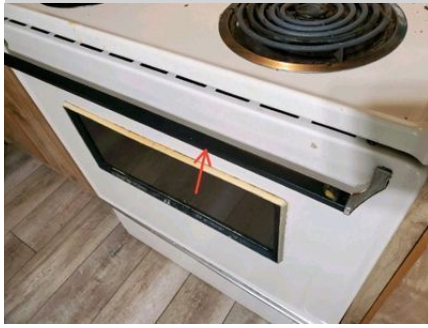
(J1-1.3) Range

The control panel, oven racks, door handle, door seal, light, were found to be damaged, not functional, or in poor condition. An appliance repair specialist should be consulted for further evaluation and repair to ensure proper operation of the appliance.

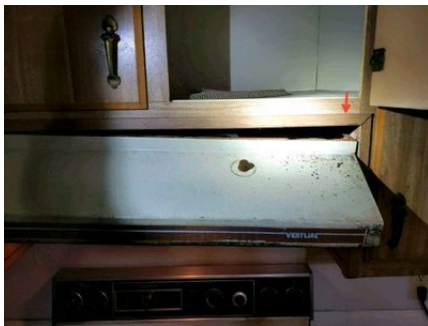
Range Hood is loose or improperly attached at kitchen area of residence. Rust is noted at metal cabinet of unit. A qualified professional is recommended to evaluate and make any needed repairs or improvements.
